# 784S-SS Aseptic MicroSpray™ Valve

## Maintenance & Parts Guide

# Valve Disassembly and Reassembly Procedures

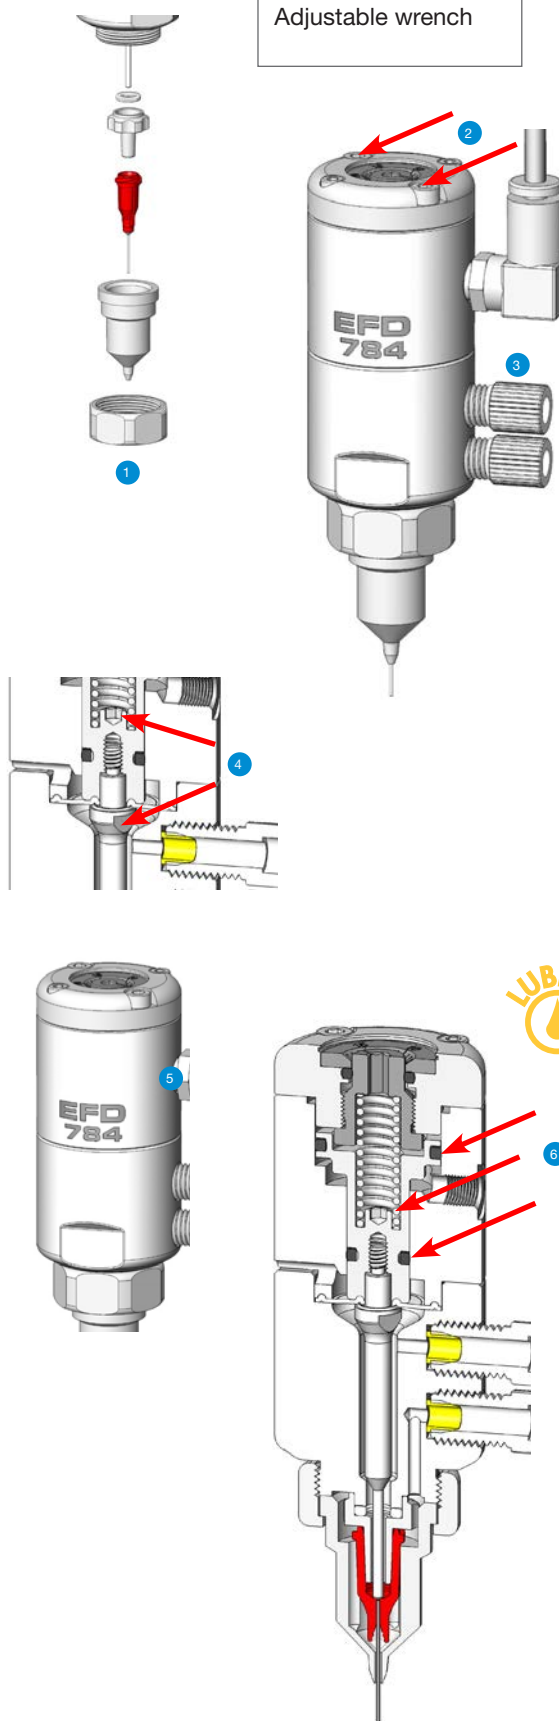
1. ❶ Remove SS air cap retainer nut, air cap, and microspray tip adapter from the fluid body. Dispose of dispensing tip. Do not reuse.
2. ❷ Remove the two retainer screws at the top of the valve to release fluid body.
3. ❸ Remove fluid inlet and nozzle air fittings.
4. To reinstall the fluid body, align fluid body holes with air cylinder body holes and reinsert retainer screws. Torque to 1.58 Nm (14 inch pounds).

5. Back out stroke control two turns counterclockwise from the closed position.
6. Remove fluid body.
7. ❹ Insert Allen wrench (2.5 mm) through stroke reference control and engage piston shaft.
8. Using the hex on the shaft, unthread shaft, and remove shaft and diaphragm.
9. Install new diaphragm onto needle shaft.
10. With Allen wrench engaged into piston, thread needle shaft/diaphragm onto piston assembly.
11. Reinstall fluid body and torque retainer screws to value specified in step 4.
12. Turn stroke control clockwise until closed, and then reopen to desired stroke.

13. Remove fluid body and diaphragm.
14. ⑤ Remove stroke control and spring by loosening stroke control retainer screws.
15. Remove the piston.
16. ⑥ Lubricate O-rings, piston shaft and air cylinder wall with Magnalube-G.
17. Reinstall components in reverse order of disassembly.

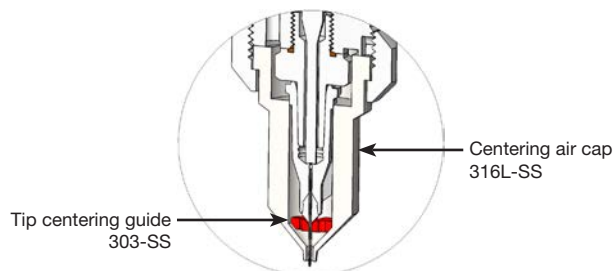
### To order aseptic microspray valves

7361024  
(784S-SS Valve)  
Microspray valve with 316L stainless-steel parts and round pattern air cap with 303-SS tip centering guide.

7012988  
(784S-SS Valve)  
Microspray valve with 316L stainless steel parts and round pattern air cap.

7013000  
(784S-SS-F Valve)  
Microspray valve with 316L stainless steel parts and fan pattern air cap.

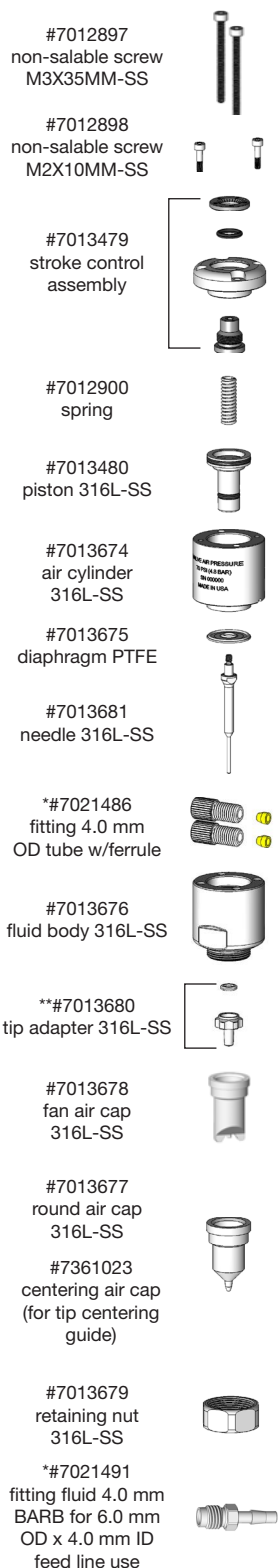
\*\*#7013682 o-ring, tip adapter PTFE, 10 pc
