752V Series Diaphragm Valve

Maintenance & Parts Guide

Valve Disassembly and Reassembly Procedures

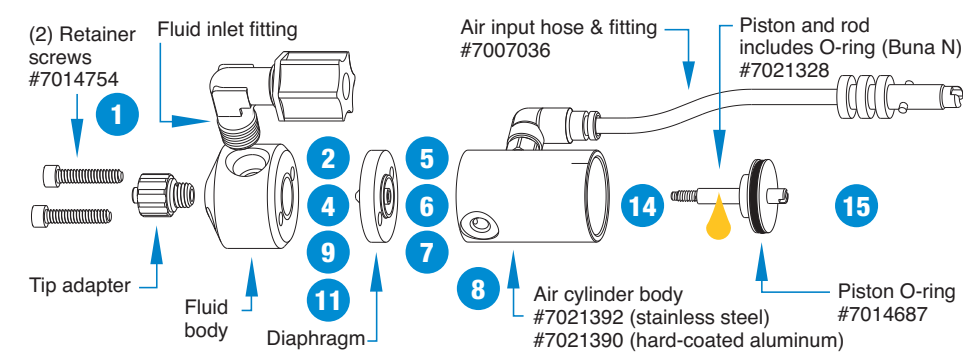
- 1 Remove the two retainer screws.
- 2 To reinstall the fluid body, align fluid body holes with diaphragm and cylinder body holes and reinsert retainer screws. Tighten in accordance with the following torque specifications:

- 3 Back out stroke control knob two turns counterclockwise from the closed position.
- 4 Remove fluid body.
- 5 Unscrew diaphragm (counterclockwise) and remove it from the piston rod.

- 6 Thread on the new diaphragm and tighten with medium pressure.
- 7 Align the holes of the diaphragm with the appropriate holes in the air cylinder body by inserting a flat tip screwdriver through the hole in the stroke control knob and engage piston rod slot.
- 8 Rotate rod, piston and diaphragm assembly clockwise until holes are aligned.
- 9 Reinstall fluid body.
- 10 Turn stroke control knob clockwise until closed, and then reopen to desired stroke.

Fluid body	newton meters	(inch pounds)
Acetal (black)	1.58 Nm	(14 inch pounds)
UHMW* (yellow)	0.79 Nm	(7 inch pounds)
Stainless steel	1.58 Nm	(14 inch pounds)

- 11 Remove fluid body and diaphragm.
- 12 Remove stroke control knob and spring by turning counter-clockwise.
- 13 Remove the piston retainer ring and anti-torque washer.
- 14 Remove the piston.
- 15 Lubricate O-ring, piston shaft and air cylinder wall with Nye Lubricant #865.
- 16 Reinstall components in reverse order of disassembly.

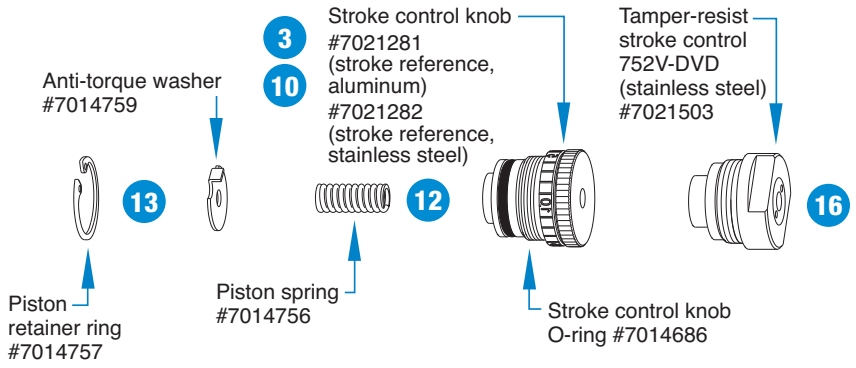
Replacement Parts for Specific Valve Models

Model	Fluid Body			Fluid Inlet Fitting	Tip Adapter	Diaphragm
	UHMW*	Acetal	Stainless			
752V & 752V-SS	n/a	7021356	7021358†	7021499 (1/4" OD Tube)	7014836	7021287
752V-UH & 752V-UHSS	7021360	n/a	7021358	7021499 (1/4" OD Tube)	7014836	7021287
752V-DVD	7021354	n/a	7021353	7021499 (1/4" OD Tube)	7014836	7021289

PTFE fluid body and diaphragm upgrade kit

7021420	Valve-PTFE Head/Diaphragm SS Cylinder
7021373	PTFE Valve Head Kit: 752V-T
7021292	PTFE Diaphragm 750 Series
